Manhole Inspection Summary

Manhole # S33M1_025MH

Location Address: **Terra Firma Road** Cross Street: **Cherry Hill Road**

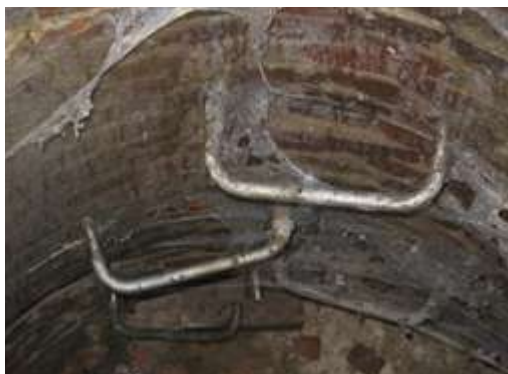
steps

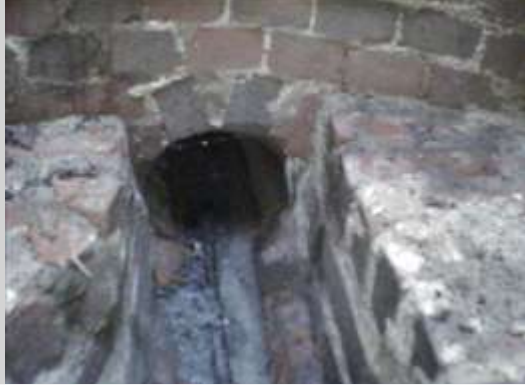
12 O'Clock Outflow

8 in. Circular Gravity Sewer
Pipe Out @ 12 O'Clock

Pipe Height: **8.4** (in.) Rod and Bar (Angled)

Pipe Material: **Clay** ☐ Pipe Lined

Invert Depth: **8.49** (ft.) Flow Characteristics: **Slow**

Infiltration: **None** Pipe Seal Cond: **Sound**

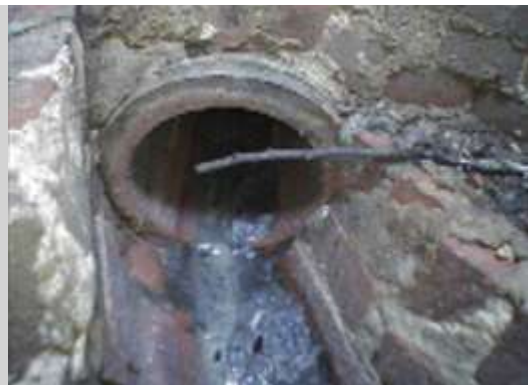
8 O'Clock Inflow

8 in. Circular Service Sewer
Pipe In @ 8 O'Clock

Pipe Height: **8.4** (in.) Rod and Bar (Angled)

Pipe Material: **Clay** ☐ Pipe Lined

Infiltration: **None**
